Radomir Ivanovik'

THE RECEPTION HALL OF THE ROMAN *DOMUS* AT THE ARCHAEOLOGICAL SITE OF STAKINA ČEŠMA – VALANDOVO

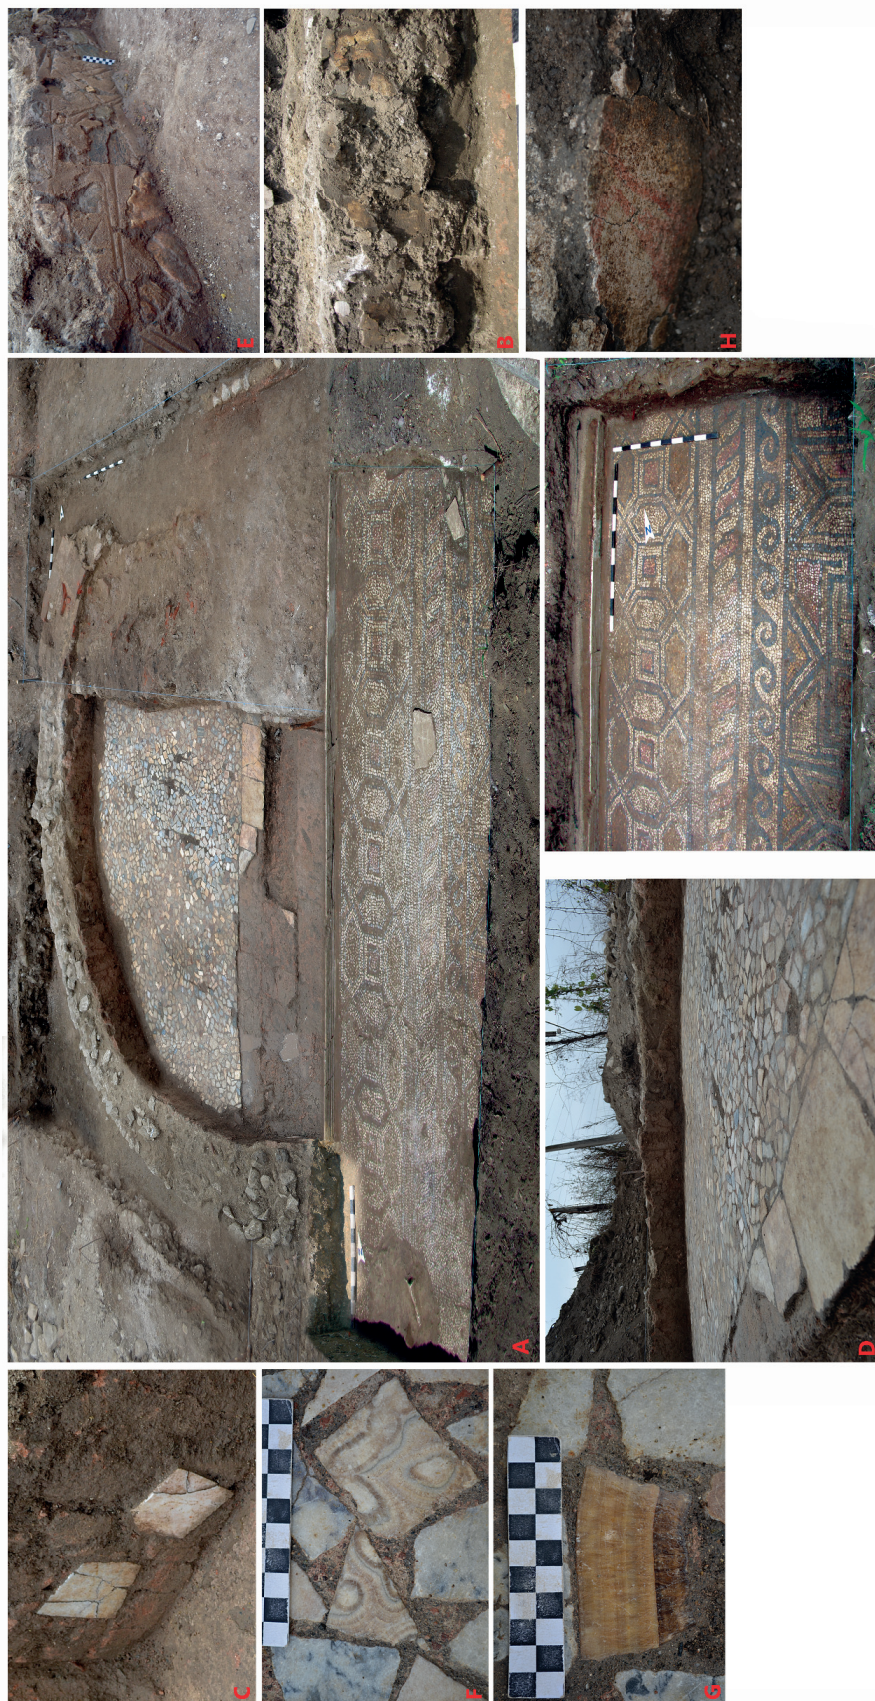
Fig. 2. Results of the investigations from 2015 to 2019 (photo: M. Šurbanovska, 2019).

At the very beginning of the excavations, the existence of a representative building was immediately confirmed. A floor in *opus sectile* and a semicircular wall of the apse were discovered [Fig. 2a]. The apsidal wall is oriented to the west and has a width of 80 cm; it is preserved 36-40 cm above the floor level. The diameter of the semicircle is 6 m, measured in the north-south direction. In the surface layer of the central part of the trench, on the apsidal wall, radially placed bricks were documented. They served as the levelling surface of the wall, which confirms the masonry, alternately made with a course of stone in lime mortar, above which there is a precisely made course of bricks in lime mortar. The inner surface of the apsidal wall was lined with a thin layer of lime plaster as a base for a 7-8 cm thick layer of hydrostatic mortar [Fig. 2b]. On the southern part of the apsidal wall, a vertical revetment of fragmented marble slabs on mortar was found, which suggests that the entire internal apsidal surface had a similar marble revetment [Fig. 2c]. The same marble slabs pave the eastern side of the floor area [Fig. 2d]. On the southern part of the outer surface of the apsidal wall, there is a precisely applied coating of lime plaster decorated with grooves [Fig. 2e].

The interior was lavishly decorated in *opus sectile*, composed of marble tiles in white and partly grey and brown colour, with inlays of semi-precious materials [Fig. 2f, 2g]. This room has been interpreted as an exedra.

At both ends of the apsidal wall, other walls continue to north and south. They have a width of 76 cm and were built of stone in lime mortar [Fig. 3]. The east face of these walls preserves remains of decorative plaster with a light-yellow base and decoration in red colour [Fig. 2h]. The walls separate the exedra from a room on a lower level to its east. The *opus tessellatum* floor in this room was made of polychrome tesserae, forming horizontal fields, filled with various motifs. Between this room and the exedra, vertically placed white marble slabs served as a facing on the stairs leading to the exedra.¹

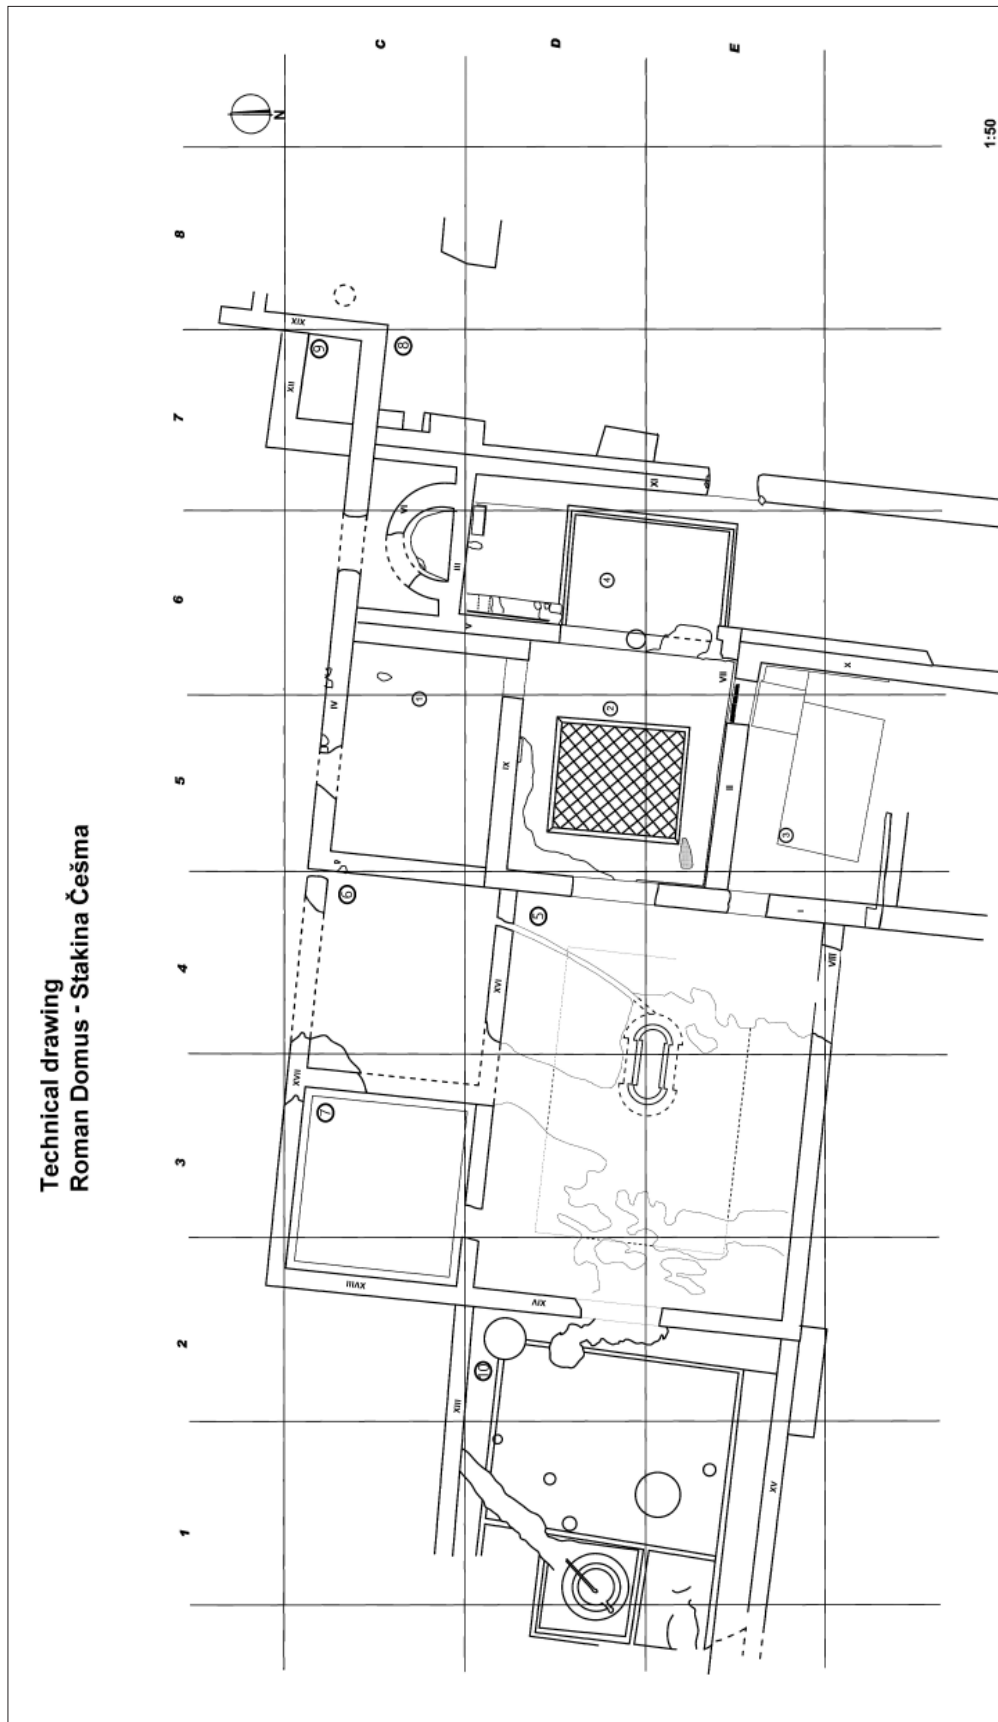
Fig. 4. Technical drawing of the entire building (plan: RIPM, L. Mangarova, R. Ivanovik', processing in AutoCAD: A. Nikolovski)

In this part of the site, an illegal dump had operated for decades, creating a garbage mound more than 2 m in height. After several days of removing garbage, we reached a level where a layer of sand and nylon could be observed in the eastern part of the trench, while the western part was intact. We eventually concluded that the eastern part of the trench had been excavated as early as 1974 during the salvage excavations executed by RIPM; unfortunately, we did not have any documentation for this part of the site. The excavations made by RIPM included only 1 m² of the room, i.e., the part next to the eastern wall. In some parts of this room, where the floor mosaic was damaged, preventive conservation with cement had been carried out. Investigation of this room continued in 2022, when the trench from 2021 was extended to the south and west [Fig. 4].

Technical drawing
Roman Domus - Stakina Češma

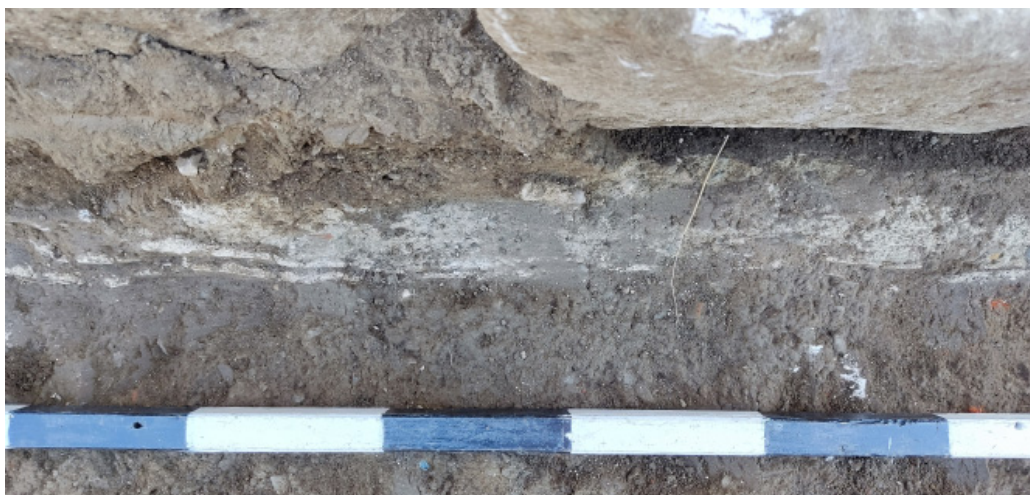
Fig. 5. Plaster lining along the southern wall no. 15 (photo: R. Ivanovik', 2022).

The excavations of the last two seasons have uncovered the northern, eastern and western walls of the new room, i.e., walls no. 13, 14 and 15 respectively. Next to walls 13 and 15, a large number of fragments of decorative plaster, painted in different colours (turquoise blue, red, green, brown and ochre), were found. On part of wall no. 15, a plaster coating with a thickness of 6 cm was documented, which was renewed at least twice [Fig. 5].

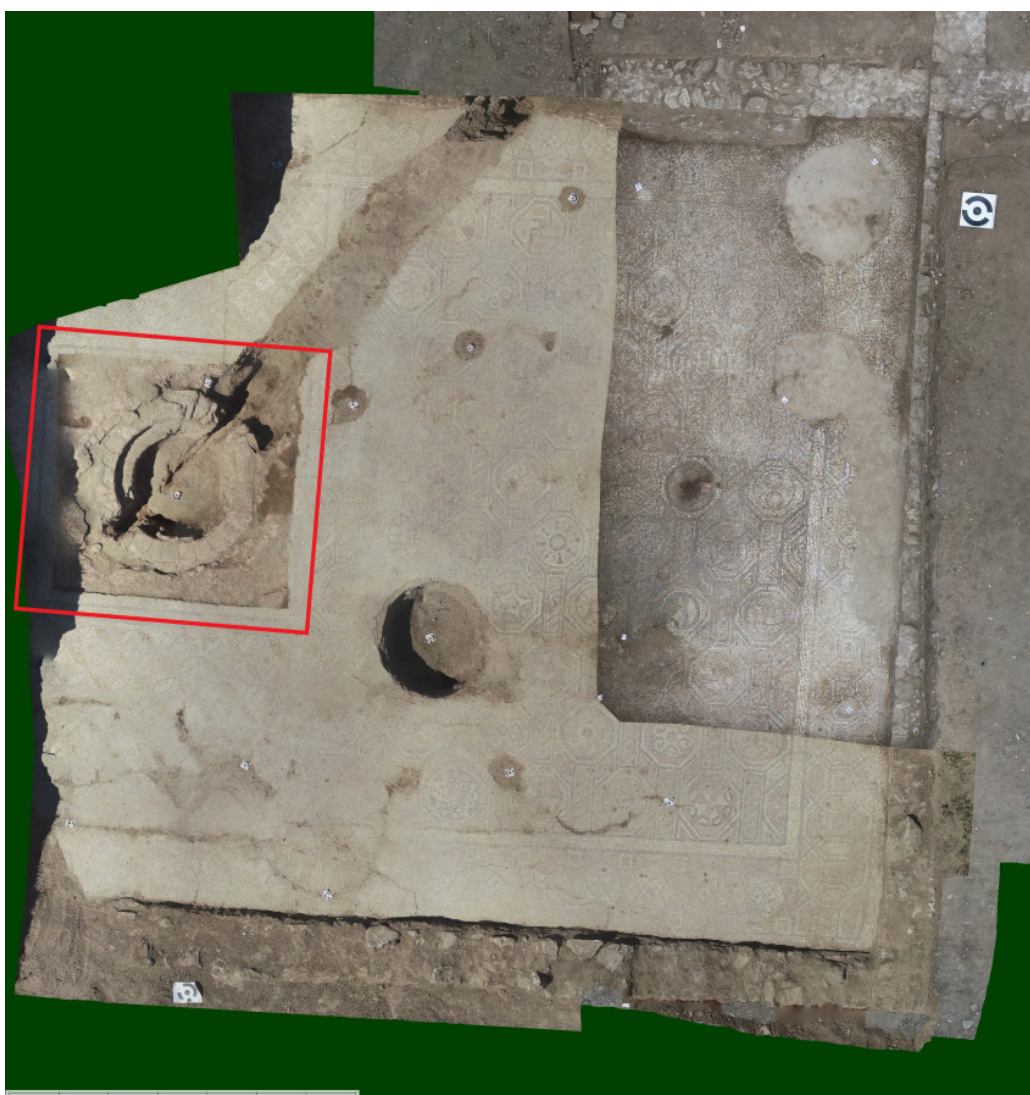
Fig. 6. The area of investigation in 2021 and 2022 (photo: H. Talevski, 2021–2022).

Due to objective reasons, i.e. the existence of modern infrastructure such as sewage shafts and a high-voltage power pole, the room was not completely excavated. Only 8.5 m along the southern side and 7 m along the northern side were investigated; the eastern side, 8.5 m wide, is fully open. The area discovered so far inside the room measures ca. 80 m²; the walls are 55 cm wide [Fig. 6].

Over the entire surface of the room, except in the center, a floor mosaic made of *opus tessellatum* was discovered. During the cleaning of the floor, at an equal distance from the southern and northern walls, a square structure with dimensions of 238 × 238 cm appeared [Fig. 6 marked red]; initially assumed to be part of a destroyed mosaic, it was identified as a centrally placed fountain. A tile found in the southeast corner of the structure appeared to be in situ, giving indications that the floor of the fountain was probably paved with this type of ceramic tiles. The interior of the fountain was filled with rubble containing more destructed tiles of the same dimensions. The upper level of the fountain was ca. 2–2.5 cm lower than the mosaic floor, and it is 60 cm deep, while the inner diameter is 1 m. The whole structure was made of hydrostatic mortar beside the bottom level of the fountain. Two ceramic tiles, preserved in situ, were attached to the walls of the fountain, and negatives of the same tiles were also observed on the walls. The interior was filled with rubble composed of hydrostatic mortar, stones, tile fragments and a small number of mosaic fragments. At the bottom of the fountain, in the middle, there is a recess, i.e., a negative impression in which a lead pipe, which supplied water for the fountain, was placed.

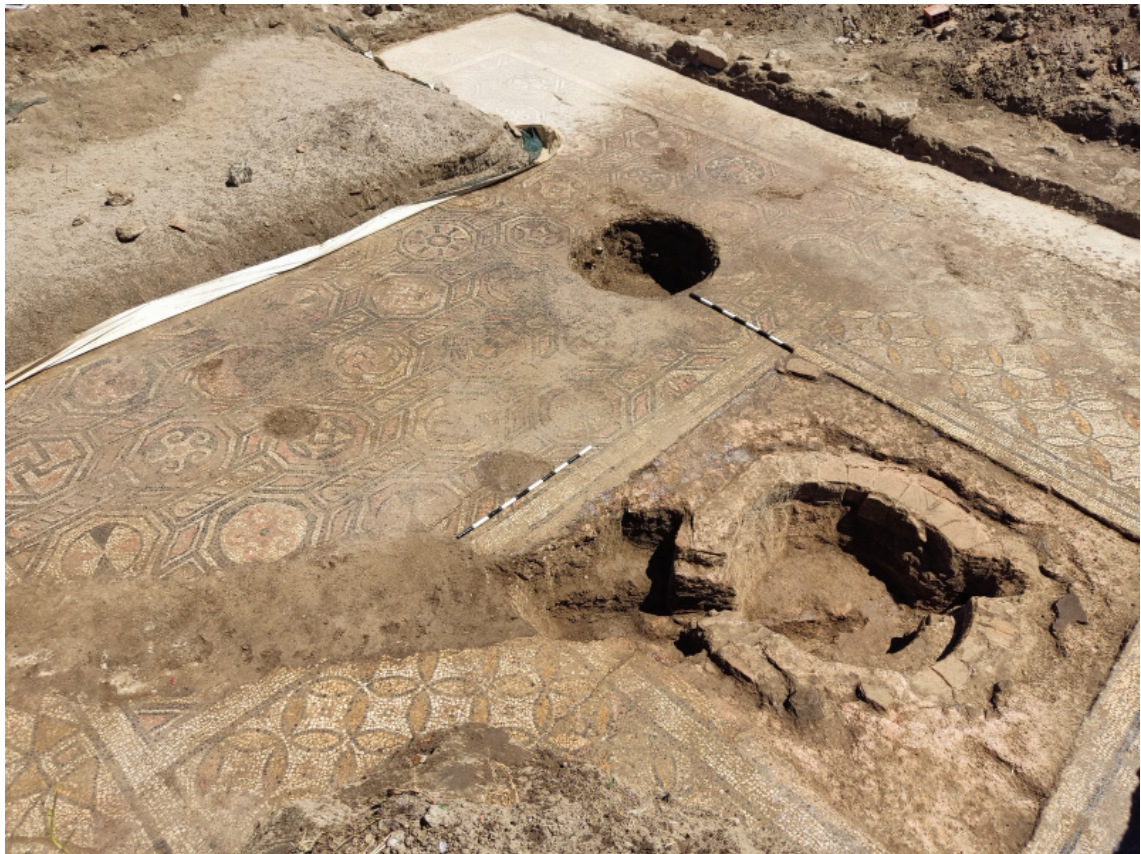
Fig. 7. The field of investigation in 2022 from the northwest (photo: R. Ivanovik', 2022).

After the fountain ceased to function, the pipe was almost entirely removed. The removal of the pipe is the reason why in the area from the northeast corner of the fountain to the northern wall the mosaic was destroyed for a width of 40–50 cm [Fig. 7]. In the southwest corner of the fountain, there is a rectangular opening where a vertical negative of the pipe was observed, where the water was diverted upwards. We assume that water flowed out through a sculpture standing at this very place.

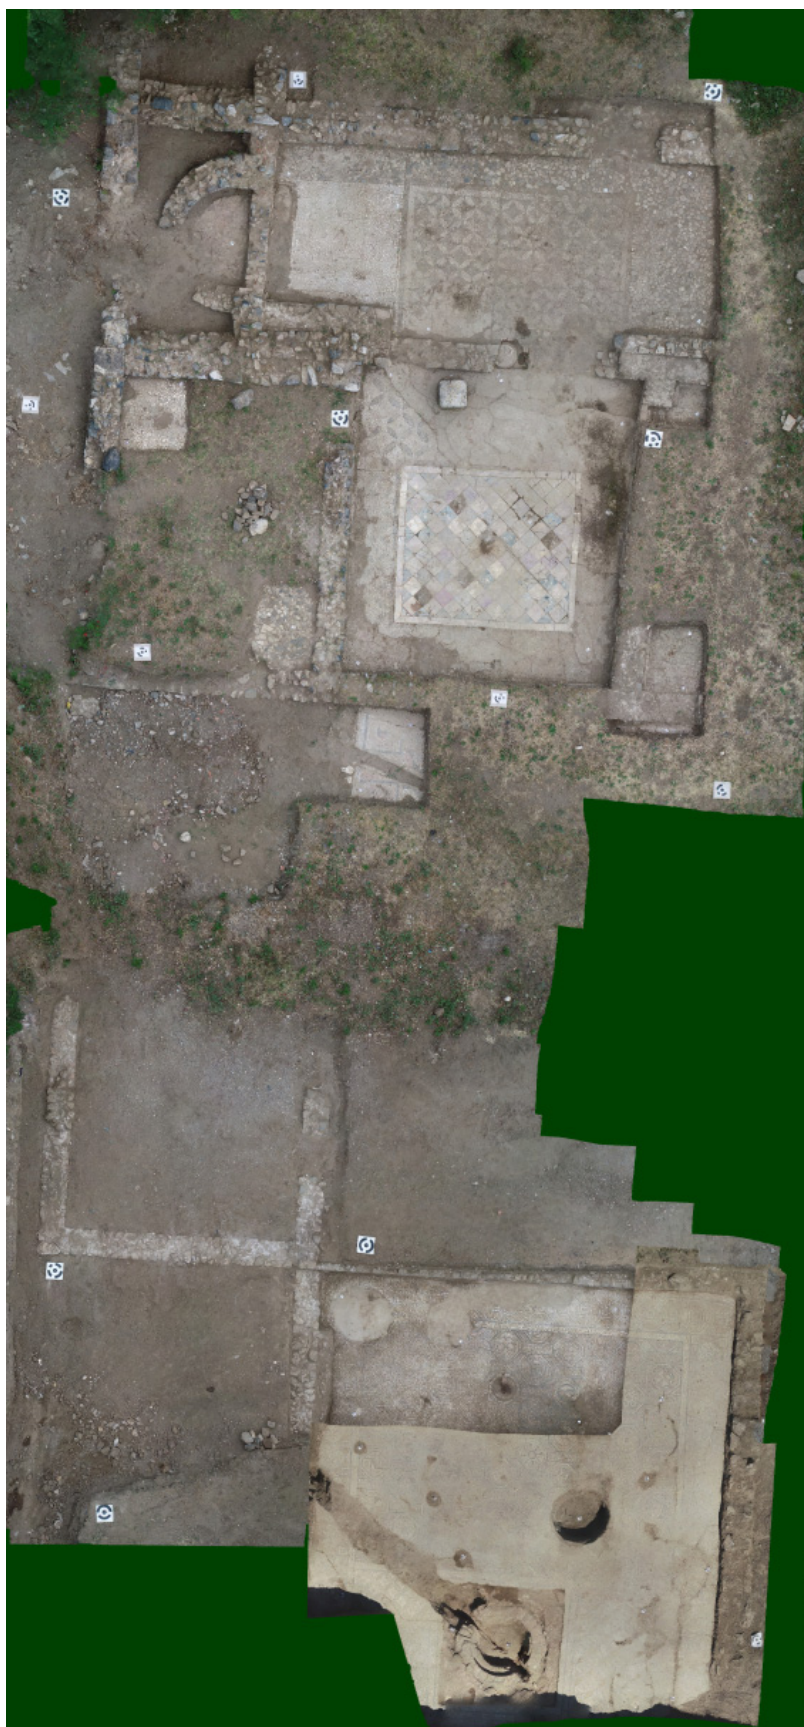
Fig. 8. Orthophoto image of the villa (photo: H. Talevski, 2021–2022).

In order to obtain a complete overview of the site, a three-dimensional geo-referenced model of the villa has been under construction since 2021 [Fig. 8], and is being supplemented by subsequent investigations.⁷

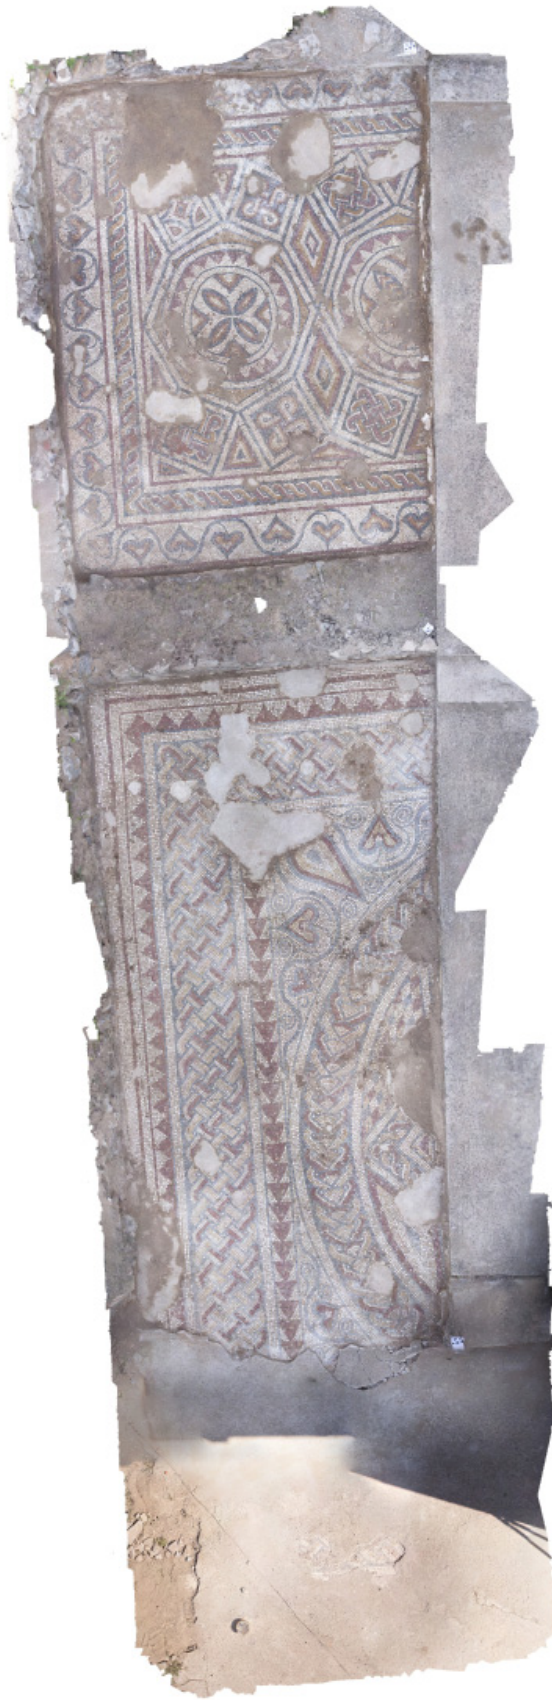
Fig. 10. Orthophoto image of the mosaic floor in Karata Maala villa (photo: H. Talevski, 2023)

reopen this site in order to see exactly what lies beneath and to properly document it. We discovered two rooms with mosaic floors in *opus tessellatum*. The larger room has a roughly square base and a complex geometric design consisting of several borders framing a central circular design with geometrical motifs, while the smaller room has a rectangular base that is completely filled with a mosaic with geometric motifs [Fig. 10]. According to the report that derived from these excavations, we know that there are at least two more buildings with floor mosaic in the immediate vicinity of the second site.¹⁰
